DEPARTMENT OF TRANSPORTATION

Contract #: 04-0120F4Cty: SF/ALA Rte: 80 PM: 13.2/13.9File #: 69.28**WELDING INSPECTION REPORT****Resident Engineer:**Pursell, Gary**Address:** 333 Burma Road**City:** Oakland, CA 94607**Report No:** WIR-002360**Date Inspected:** 15-Jan-2008**Project Name:** SAS Superstructure**OSM Arrival Time:** 1300**Prime Contractor:** American Bridge/Fluor Enterprises, a JV**OSM Departure Time:** 100**Contractor:** Zhenhua Port Machinery Company, Ltd (ZPMC), Changxing Island **Location:** Shanghai, China**CWI Name:** Xu Le Feng, Sha Zhi**CWI Present:** Yes No**Inspected CWI report:** Yes No N/A**Rod Oven in Use:** Yes No N/A**Electrode to specification:** Yes No N/A**Weld Procedures Followed:** Yes No N/A**Qualified Welders:** Yes No N/A**Verified Joint Fit-up:** Yes No N/A**Approved Drawings:** Yes No N/A**Approved WPS:** Yes No N/A**Delayed / Cancelled:** Yes No N/A**Bridge No:** 34-0006**Component:** Tower Mock-Ups**Summary of Items Observed:**

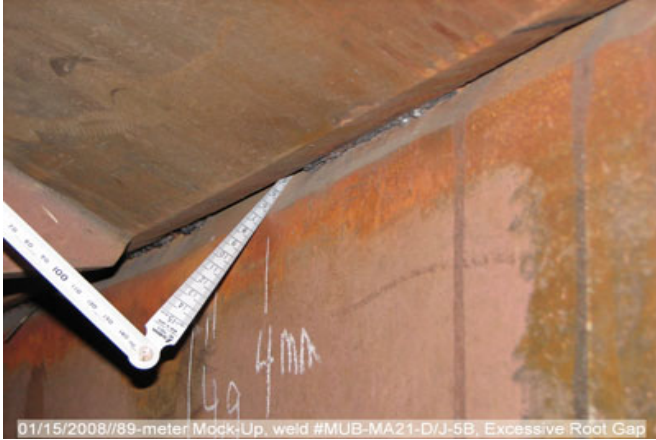
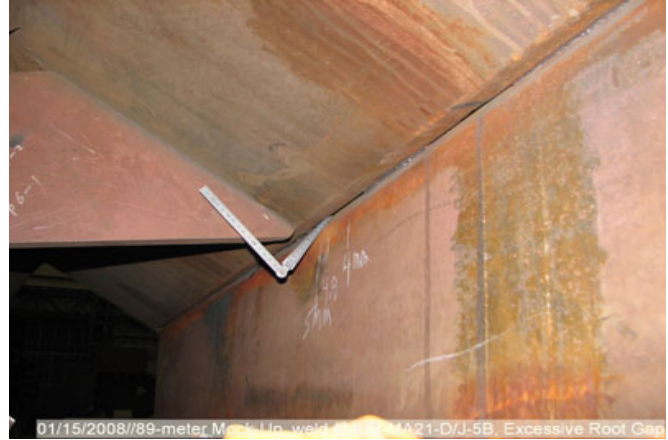
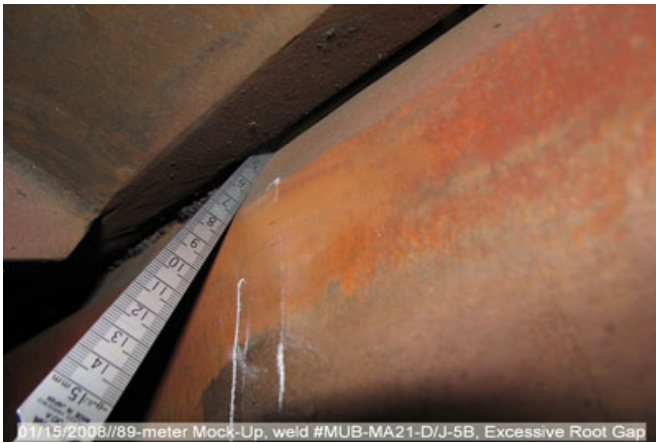
The QA Inspector observed Z. P. M. C. welders Lei Lichao, ID #053619, Li Moughqian, ID #054460, and Li Zhaoqian, ID #048810, weld Skin A to Skin B, the weld number is MUB-MA21-D/J-2A, using Welding Procedure Specification (WPS)-B-T-2232-B-U4b-F. The three (3) welders shared two (2) welding machines. The QA Inspector verified the WPS parameters and recorded the following at different times, 319 amps, 30.4 volts; 317 amps, 30.7 volts; 323 amps, 30.3 volts.

The QA Inspector was asked to check a possible 4 mille-meter (mm) root gap, at the 89-meter Mock-Up. The following measurements were taken at the weld root of joint number MUB-MA21-D/J-5B. The measurements started 460 mm from the end of the weld, slightly off center, 5.2, 5, 4.9, 4, 4.3, and 3.5 mm's. Starting 107 mm's from the end of the joint the measurements were as follows 3.6, 2.8, 2.6, 1.8, and 1.8 mm's.
